# Remanufactured Process for Pipeline and Centrifugal Pumps

By **George J. Maddox**, P.E., PumpWorks

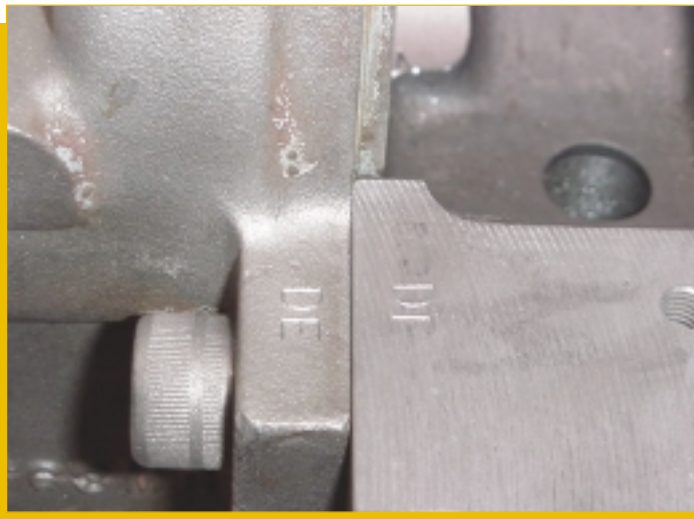
The parts shown have been carefully match marked during the disassembly process to ensure a mismatch does not occur during the final assembly of the pump.

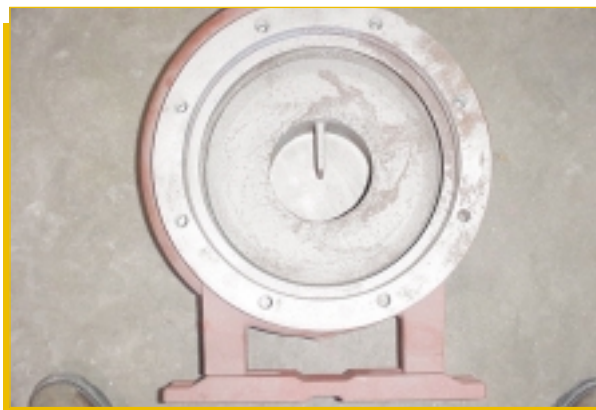
During the inspection process some erosion was found near the suction nozzle. This case will be weld-repaired, stress-relieved and an NDE performed to test the integrity has been restored.

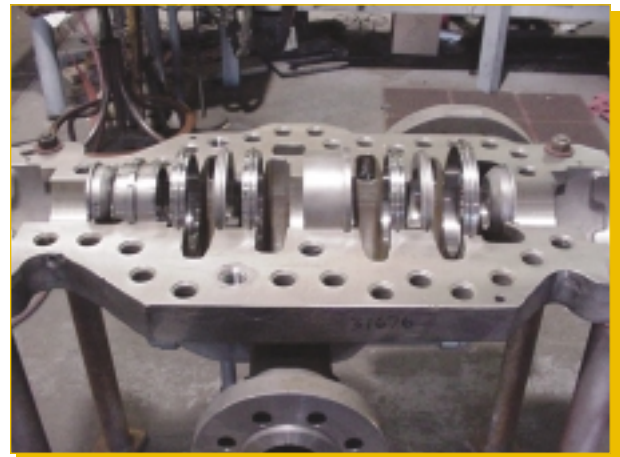
This case has been planed and bored and is in final inspection. Each volute throat area has been inspected and ground to match a template provided by engineering.

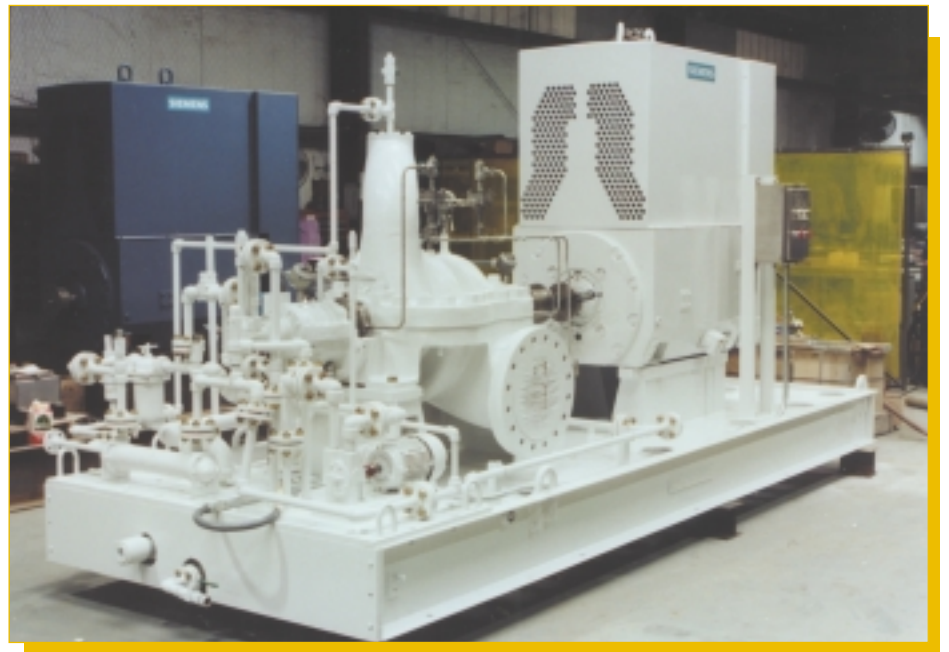
River water transfer pump for Syrian installation. PumpWorks remanufactured Ingersoll-Rand 8PH-2 two-stage 316 SS pumps packaged with 600 hp motors, Sleeve/Kingsbury thrust bearings and force feed lube oil system. Unit remanufactured, tested and shipped in 14 weeks.

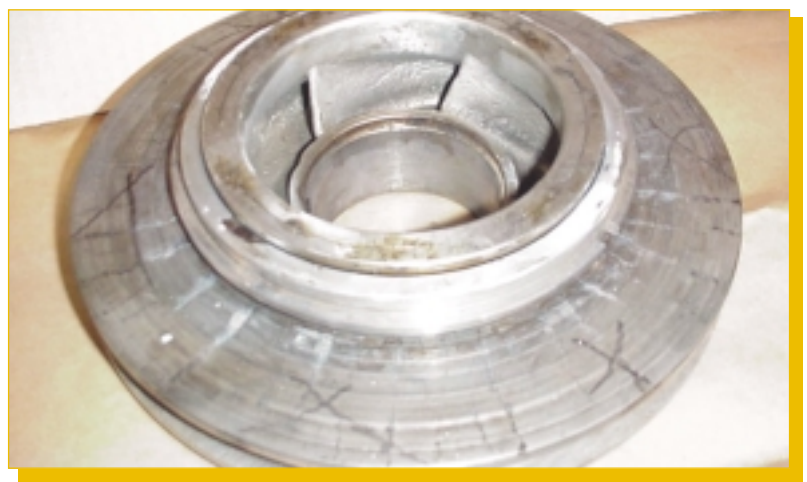
The impeller pictured here has cracks in the shroud that are irreparable. As a result this impeller will not be used in the remanufacturing process.

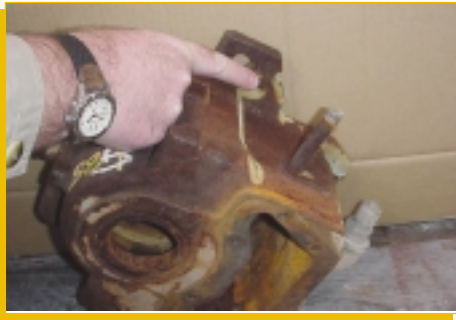
During the preliminary inspection of this bearing housing a piece of the support was found to be broken off requiring the housing to be replaced.

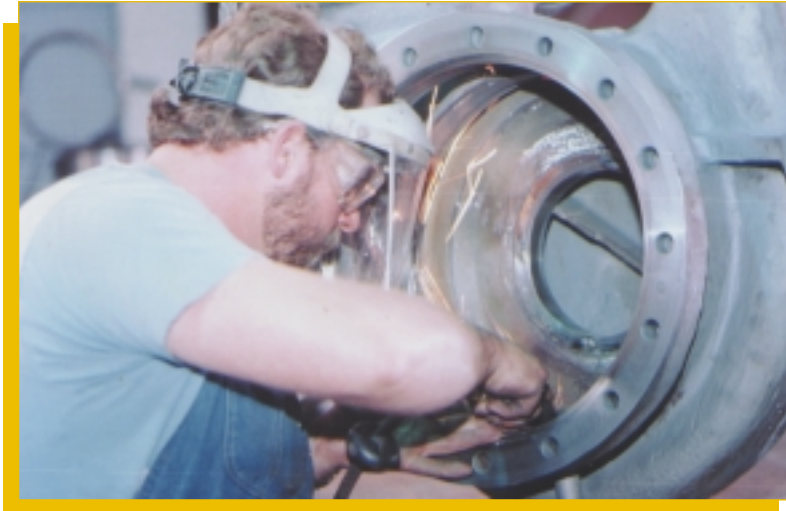
Single stage casing being reworked to match impeller for hydraulic rerate.

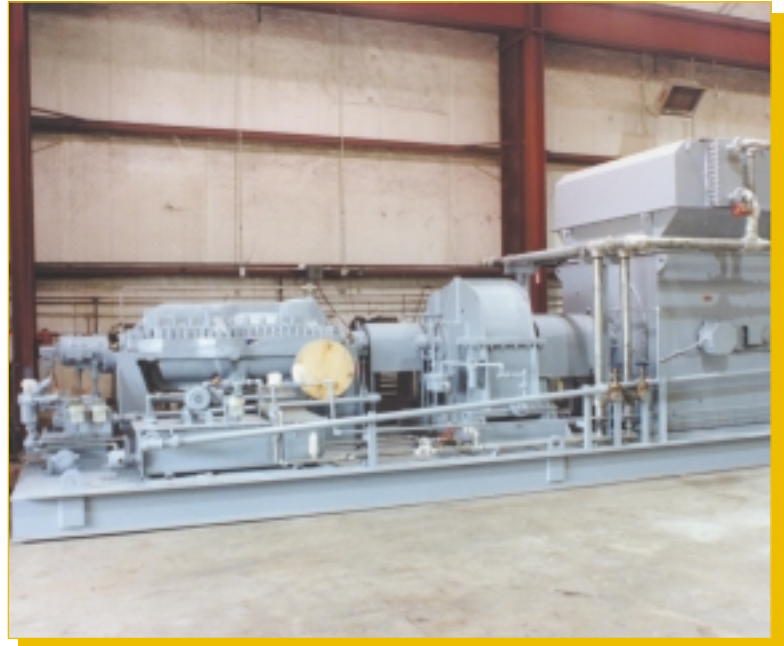
PumpWorks remanufactured Union MQE coke cutter pump, gearbox, lube system and 3000 hp, 6000 V, 50 Hz motor. Unit remanufactured and shipped in 10 weeks.

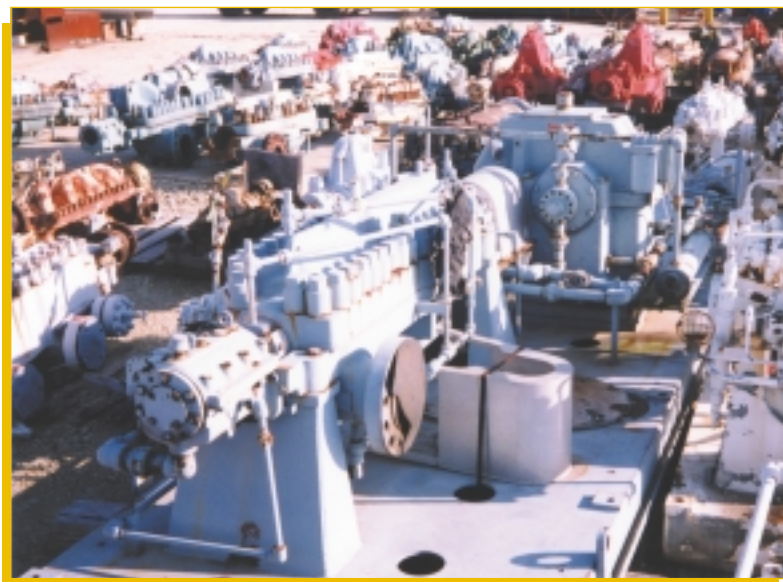
Examples of some of the more than 1000 used multistage pumps in PumpWorks' inventory.
